CARRINGTON CCGT POWER STATION

Asbestos Fibres in Soils

PROJECT SCOPE

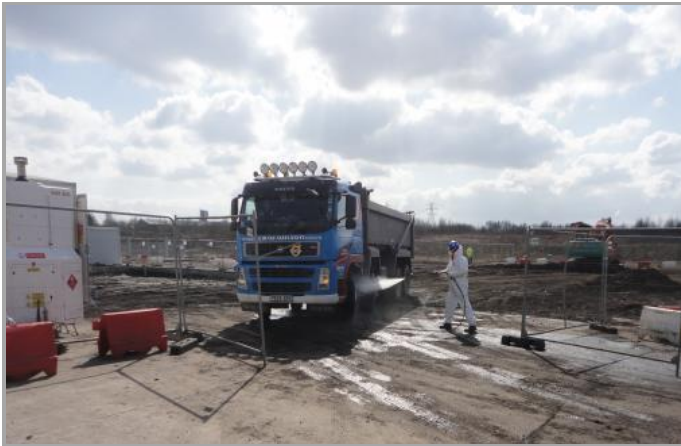
JET WASHING THE WAGONS EXITING THE CONTROL ZONE, PRIOR TO USING THE WHEEL WASH

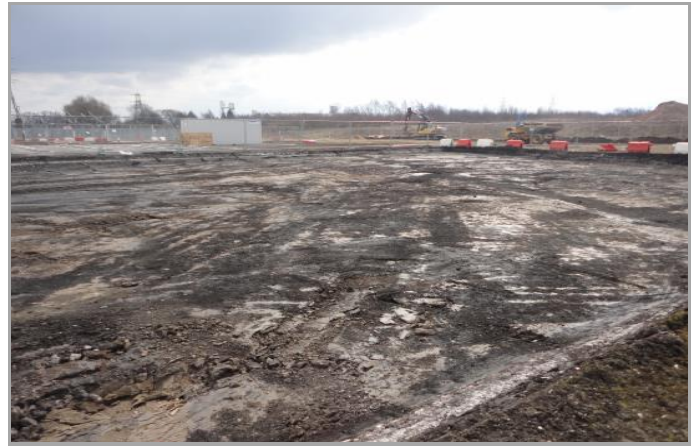
SECTION OF EXCAVATED CONTROL ZONE

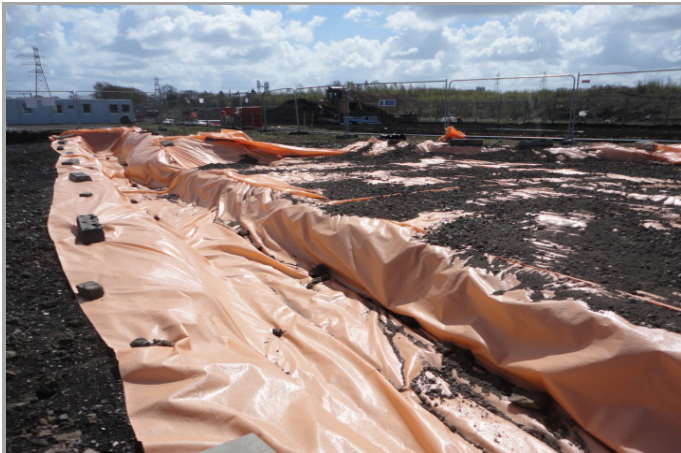
INSTALLATION OF WARNING GEOTEXTILE LINING ALL EXCAVATED SERVICE TRENCHES AND EXPOSED SITE AREA

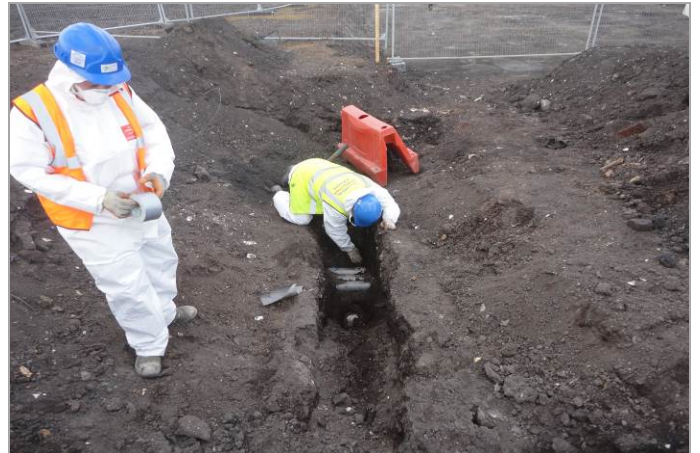
HAND EXCAVATION AROUND LIVE SERVICES

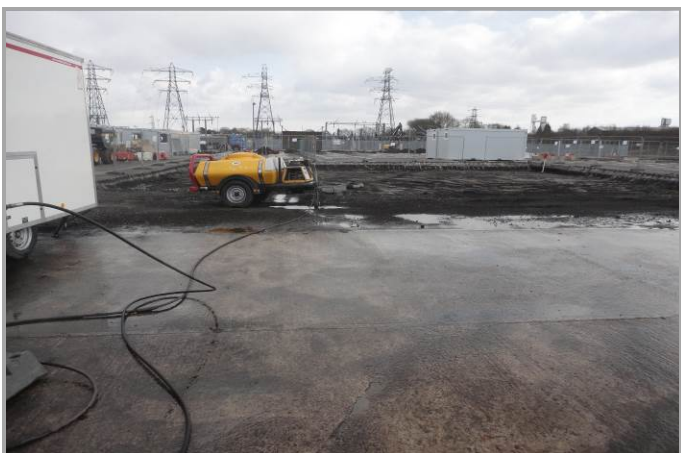
ACCESS AND EGRESS AREA OF A CONTROL ZONE SHOWING DECONTAMINATION UNIT AND JETWASH BOWSER

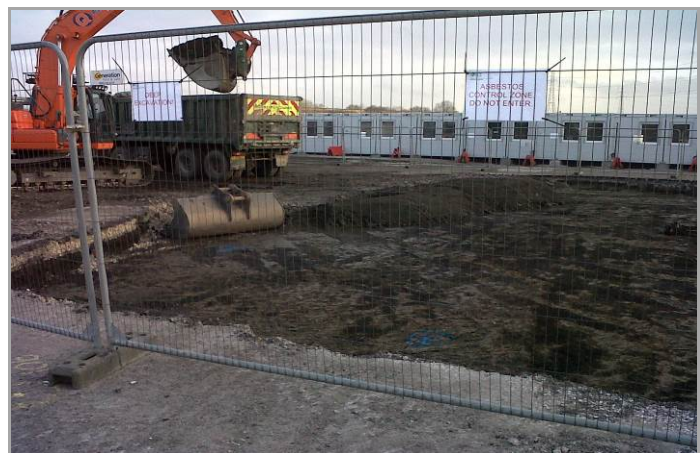
LOADING CONTAMINATED SOILS FOR OFF-SITE DISPOSAL
